SUBJECT Technical Report on MIG-15 BIS

TECHNICAL REPORT  
ON  
MIG 15 BIS  
NO 1327

PART ONE  
AIRFRAME

The following report is based upon information gained from examination of a Polish built aircraft (known as "FAGOT"), designated LIM-2 (Polish designation for the USSR MIG-15 Bis) 25X1

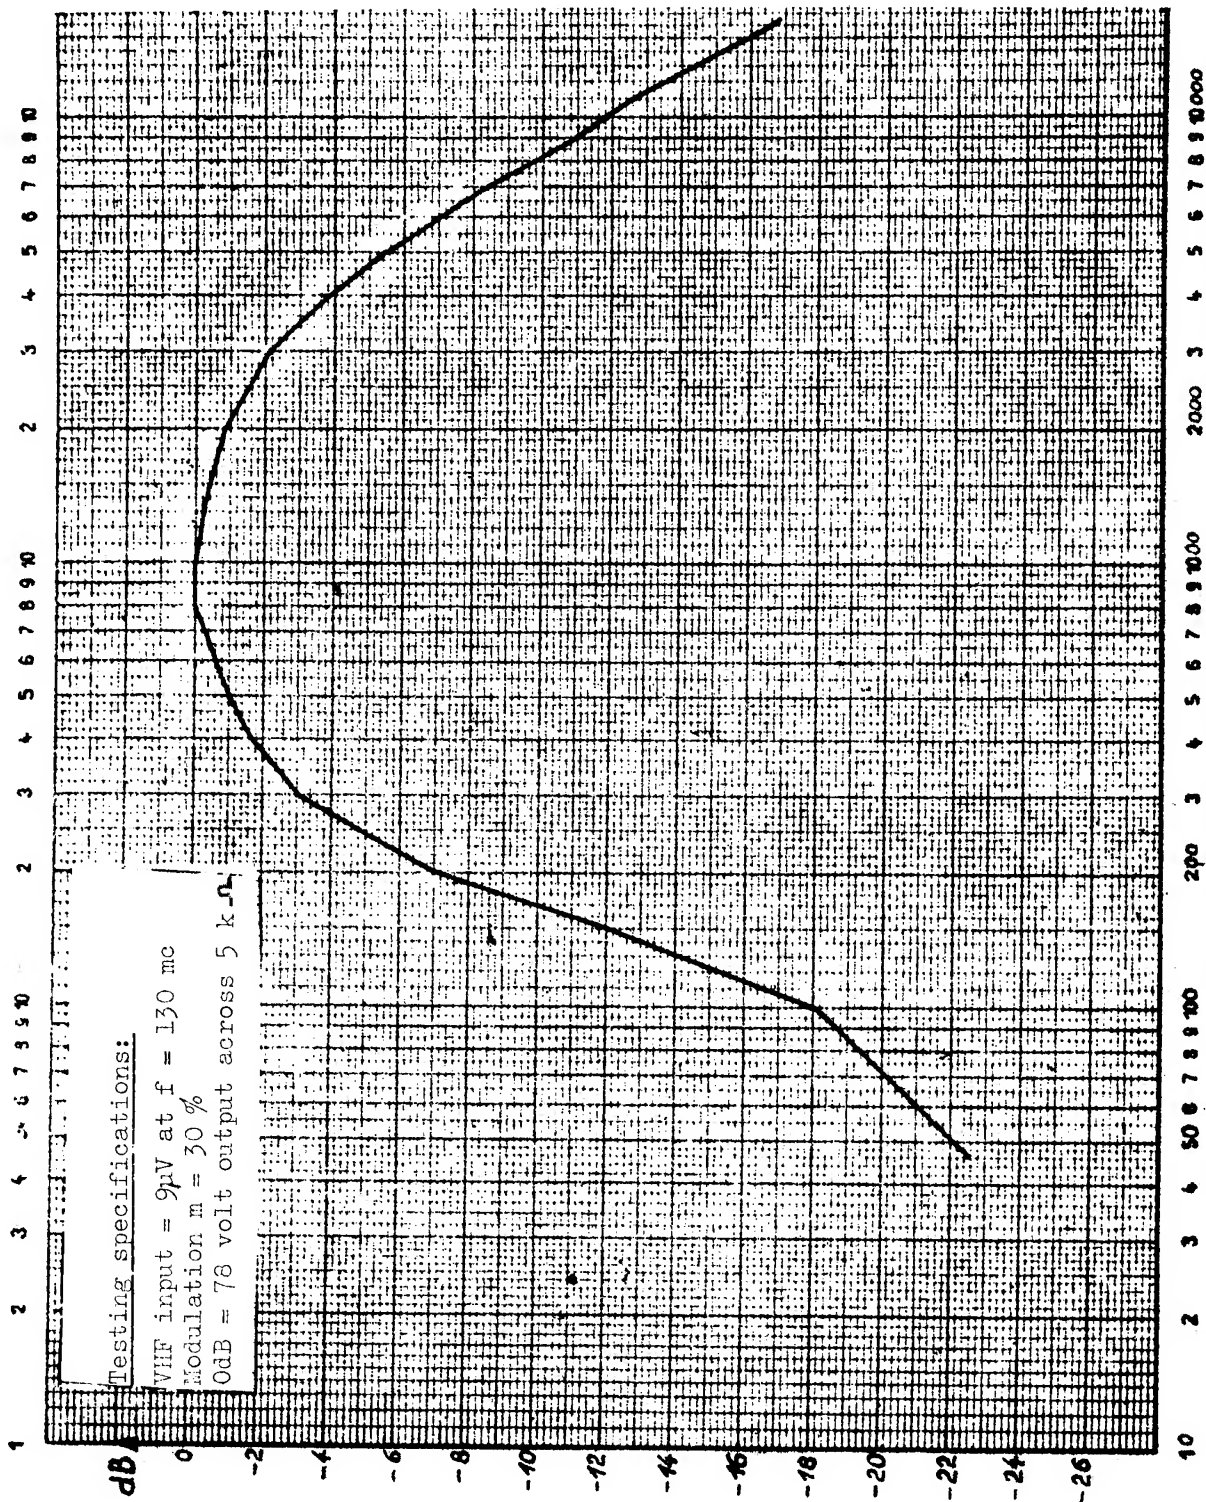
Fig. 3-50.

## AUDIOFREQUENCY CHARACTERISTIC OF RECEIVER

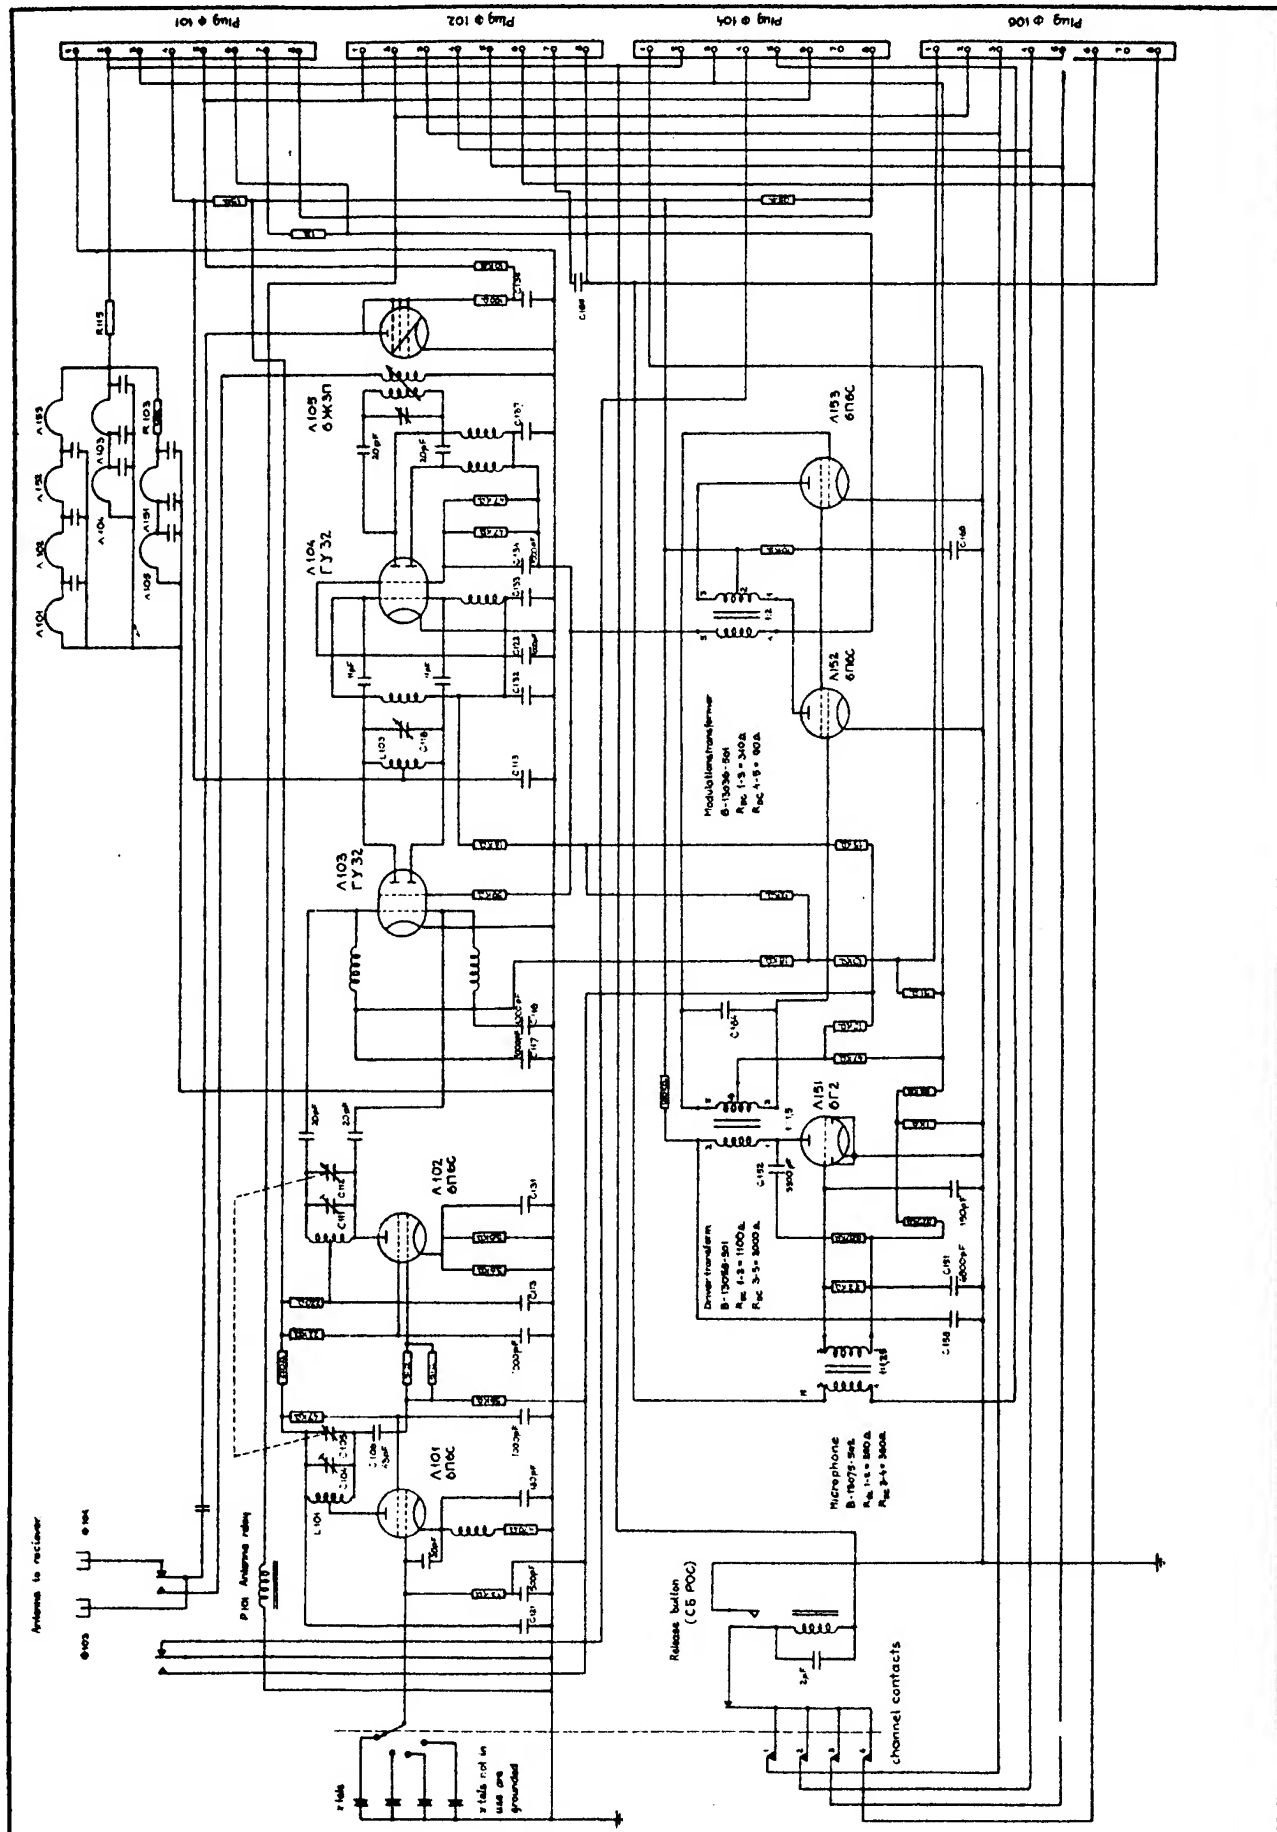
Dwg. no. 1.

### CIRCUIT DIAGRAM OF VHF TRANSMITTER.

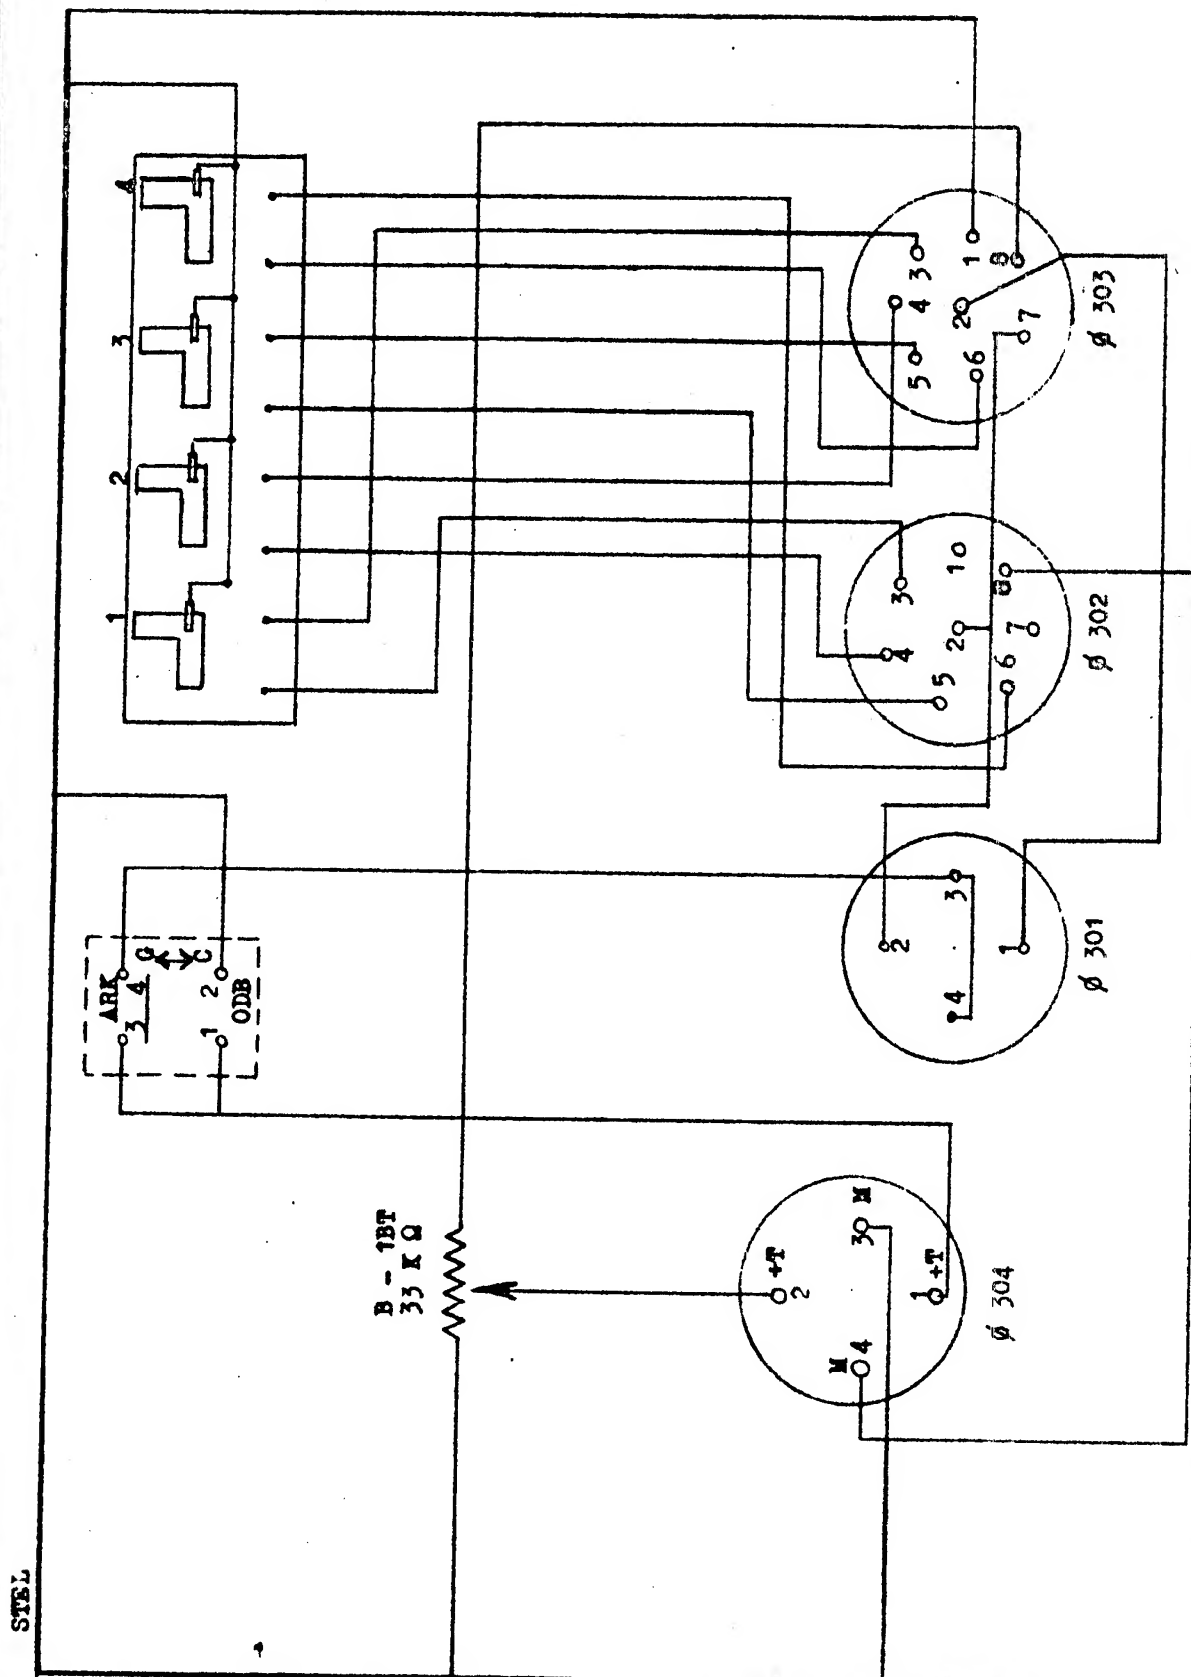
Dwg. no. 4.

VHF SET RSI-U-3M.  
CIRCUIT DIAGRAM OF CONTROL BOX.

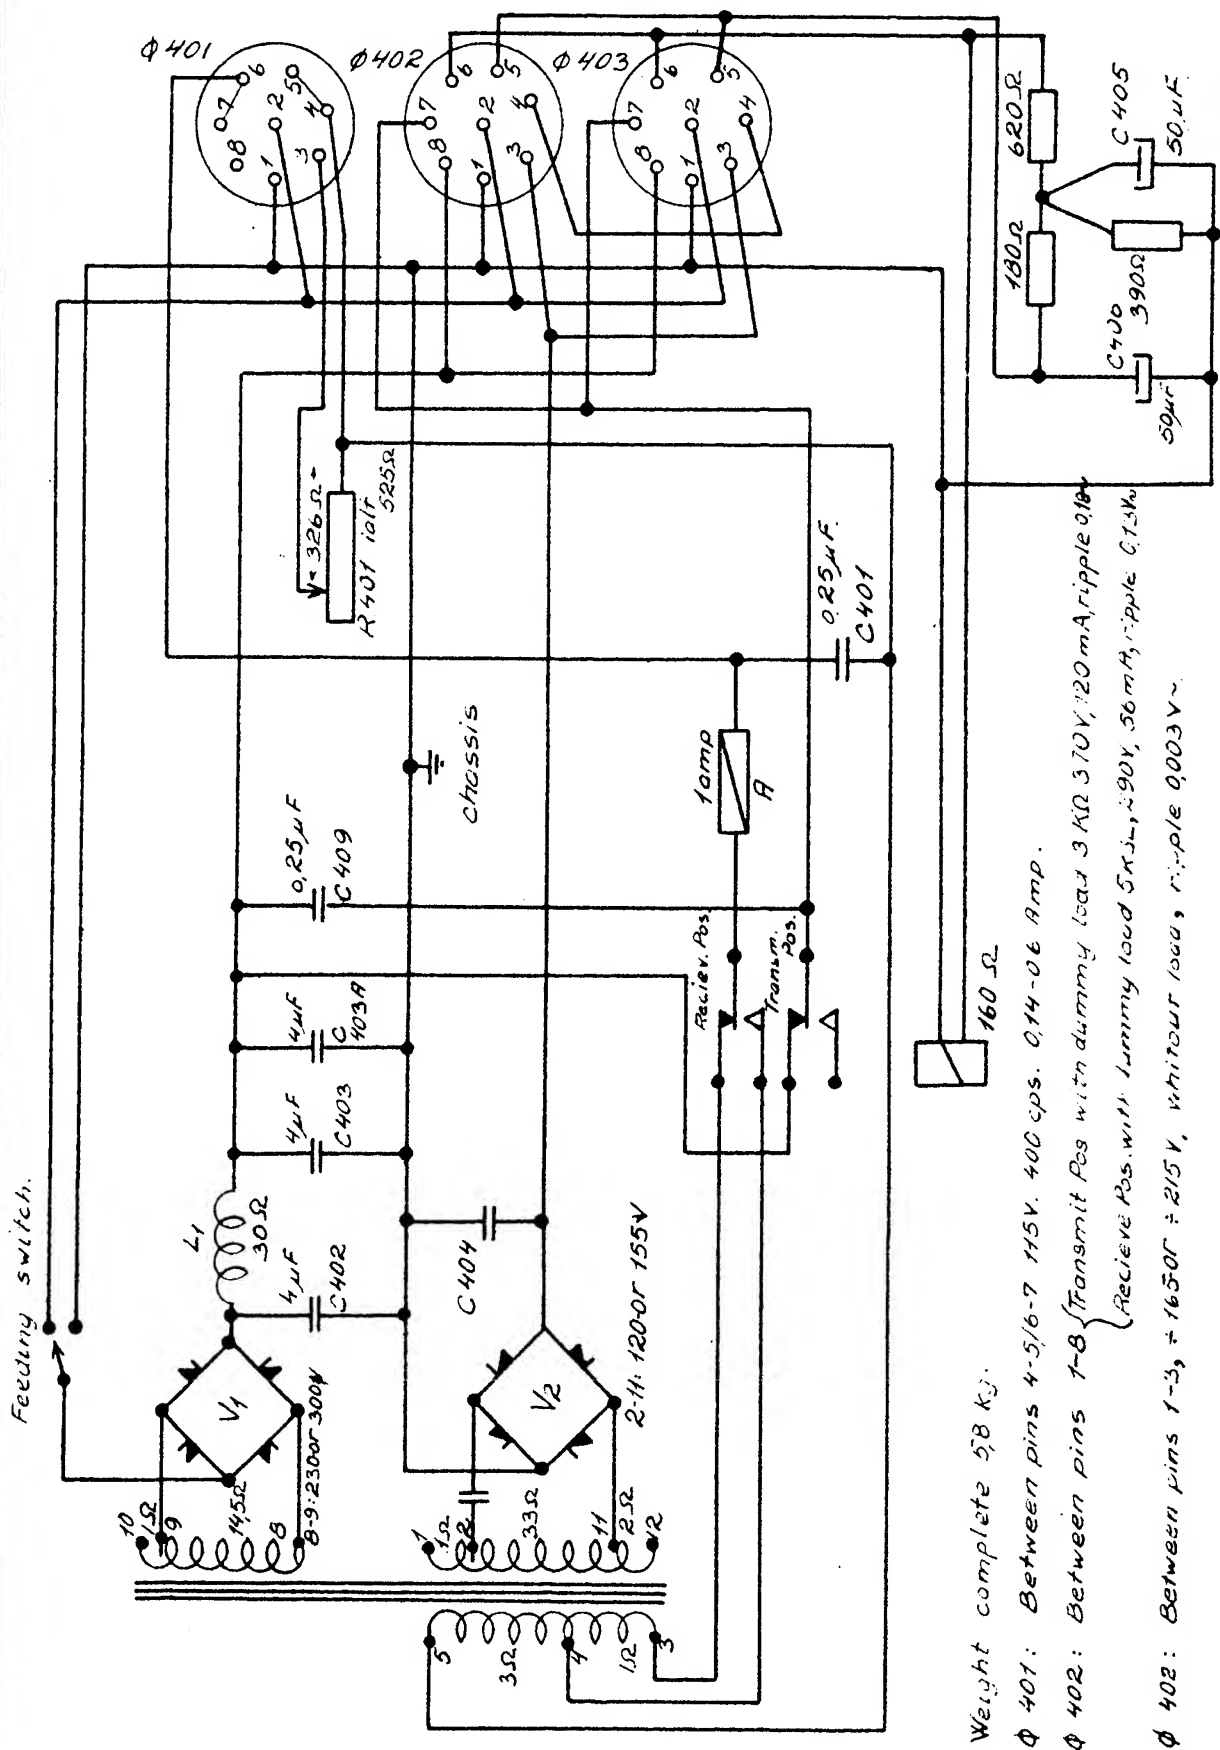
VHF SET RSI-U-3M.  
CIRCUIT DIAGRAM OF  
VHF POWER SUPPLY. TYPE BM.

Output regulated to 115V/0,87 Amp,  $f=380$  cps with 10% 3. harmonic and less than 1% other harmonics

Total weight 7,1 kg.

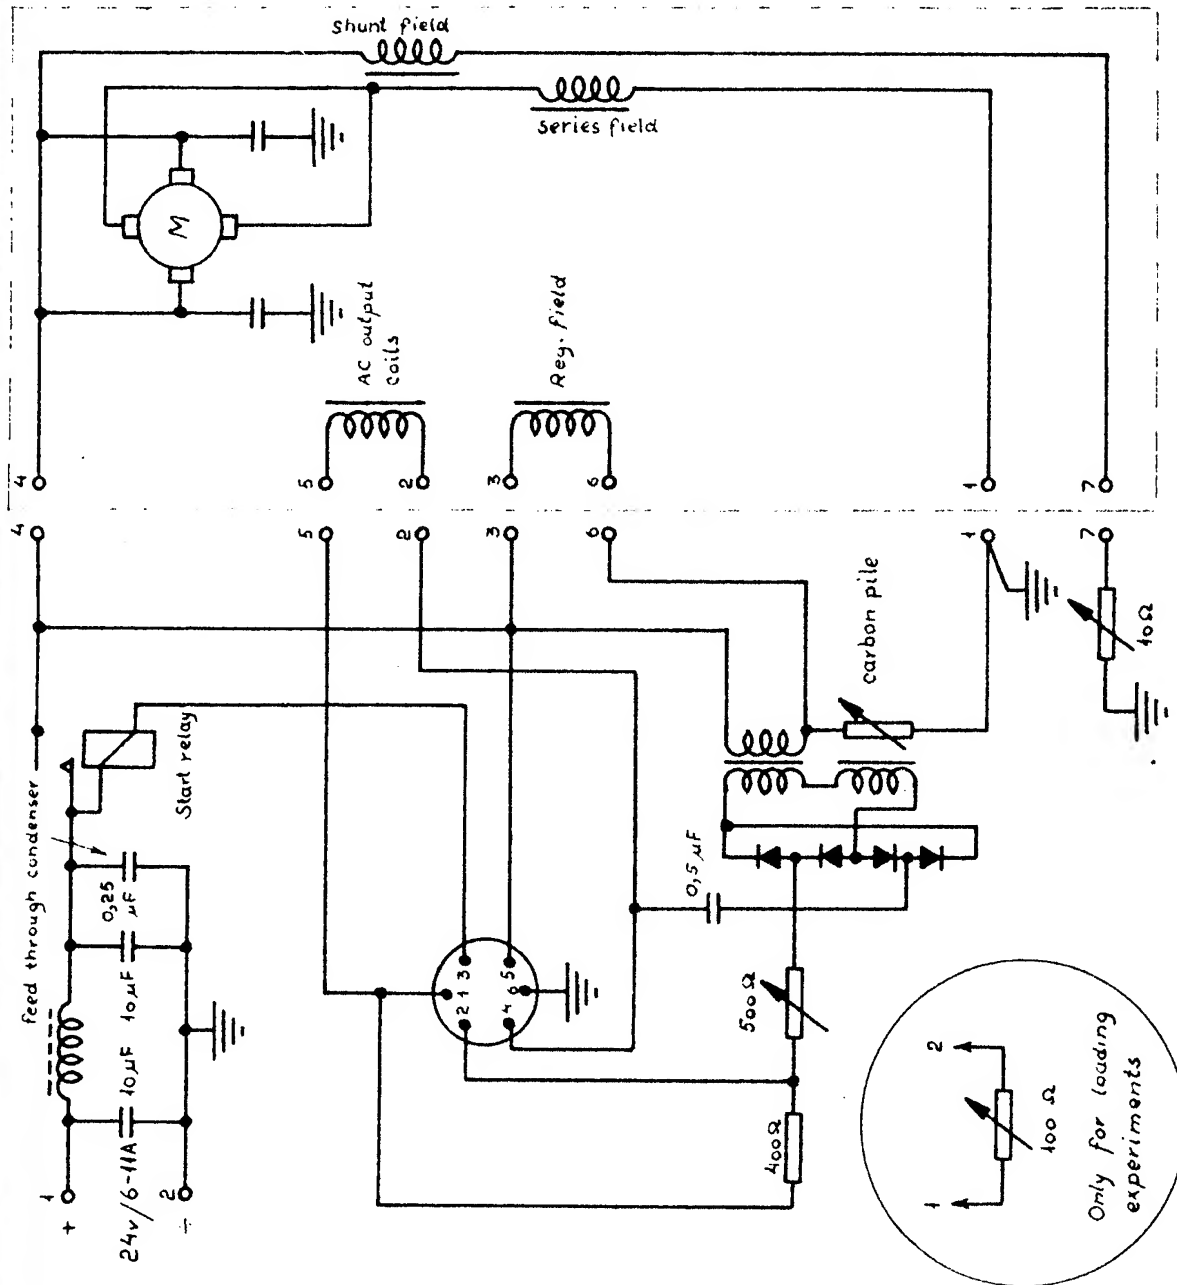
CIRCUIT DIAGRAM OF INVERTER UNIT TYPE MA-100M.

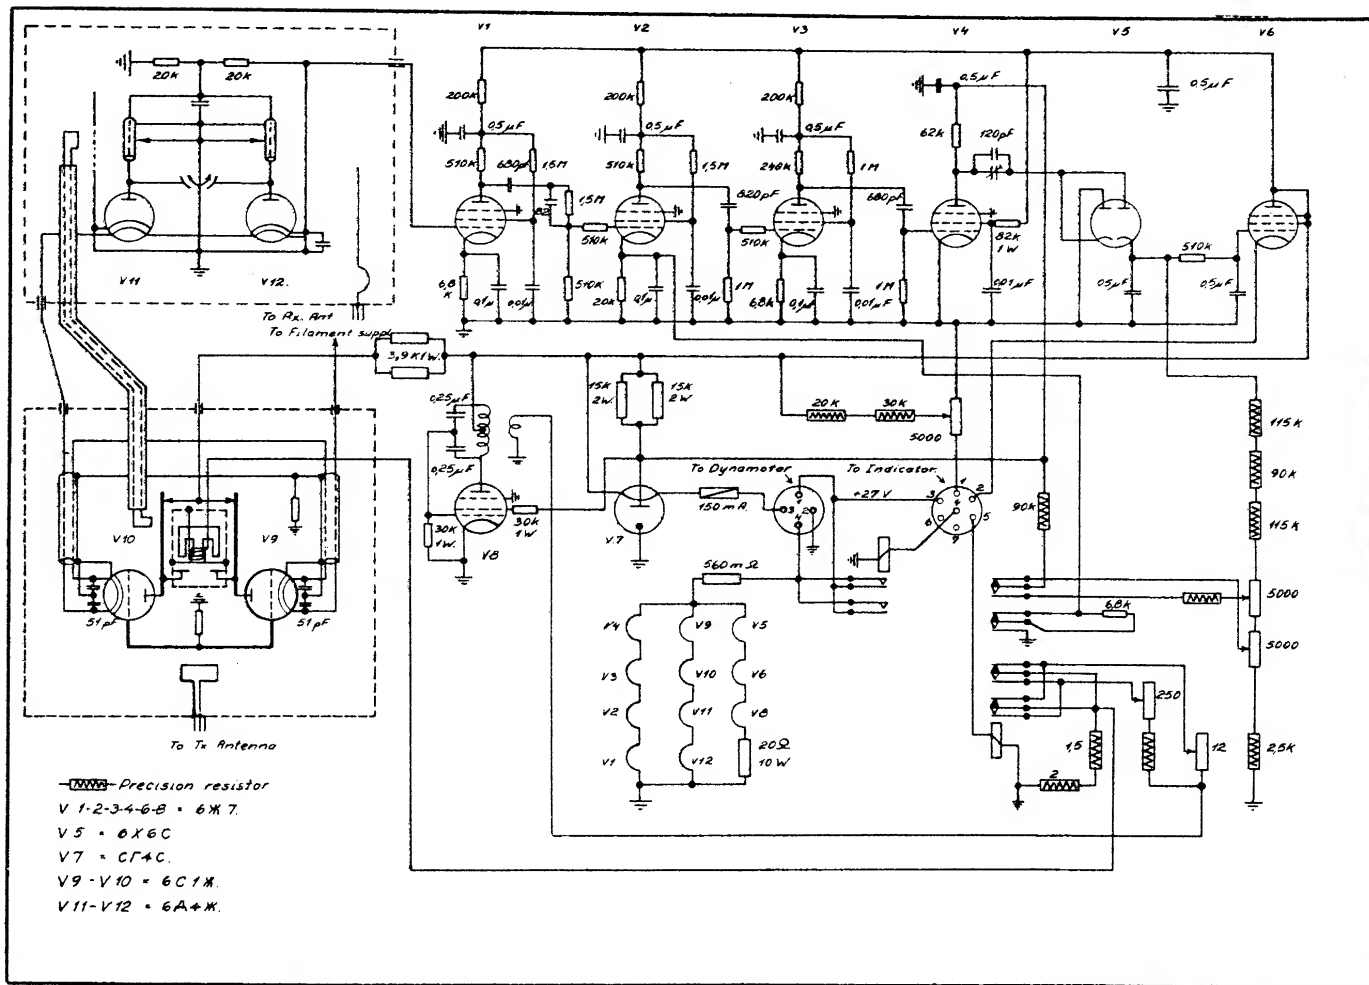
DWG. no. 8.

FM RADIO ALTIMETER RV-2.

Only minor modifications were noted. A revised circuit diagram is shown in drawing no. 8.

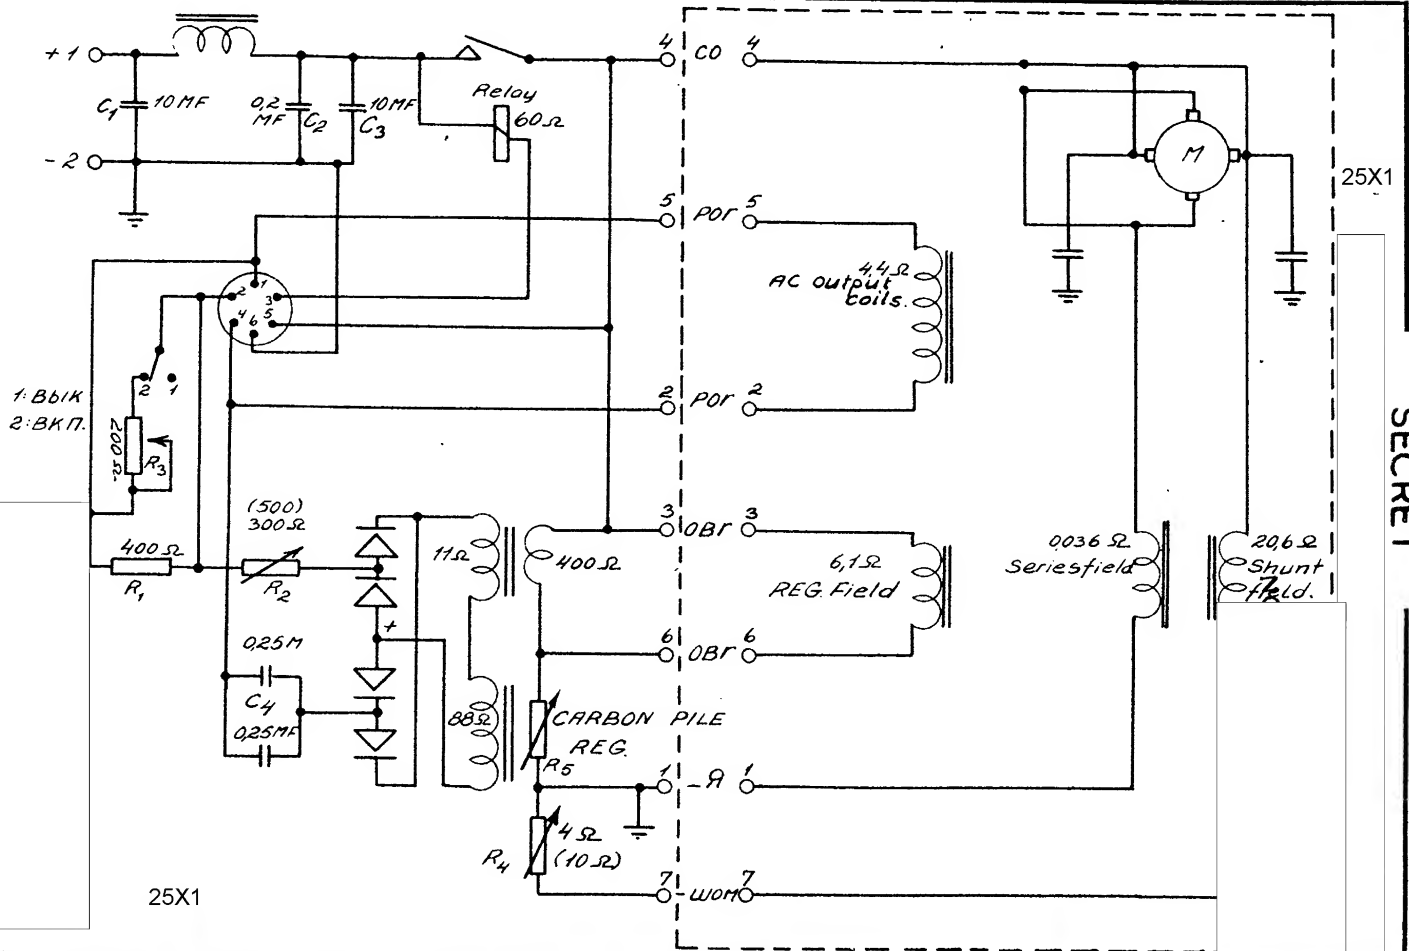
DWG. no. 11.

RADIO COMPASS ARK-5.  
INVERTER TYPE MA-250M.
